Application No	DA2400094
-----------------------	-----------

Property Location	273 Phipps Road Runnymede
--------------------------	---------------------------

APPLICATION FOR PLANNING PERMIT – USE AND DEVELOPMENT Residential Use

New Dwelling

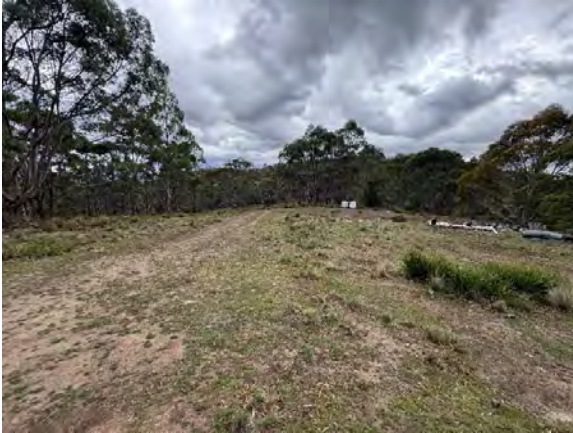
From house site to East

Direction	First slope	vegetation	Second slope	Dist/veg
East	-2° for 44m	Grassland	level	Woodland
South	-4° for 30m	Grassland	-14°	Forest
West	+3° for 30m	Grassland	level for 57m	Woodland
North	-6° for 53m	Grassland	-16°	Woodland

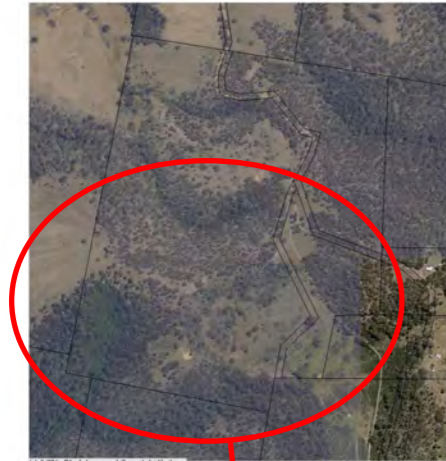
The Hazard Management Area covers the part of the site outlined in green. Grass-based HMA management is required within the inner (solid line) area, and no significant tree growth is permitted within the outer (dotted line) area.

House construction must meet **BAL-29** specifications. Within the HMA maintain lawn to 25mm, kept green if possible, garden with only isolated trees and scattered shrubs at least 2m from walls & 5m from windows, or a paved/gravel surface. Nearby tree-based (Woodland & Forest) vegetation is naturally sufficiently far from the house site to meet HMA specifications, but tree growth must not be permitted to encroach within the outer (dotted line) area. The specified outlet from a metal tank with 10kl reserved for fire fighting is to be installed in the approximate area shown, next to the access road, within 3m of parking for a fire tanker, and between 6 & 90m from the building. Refer to Annexure C of the report for detailed specifications.

Alignment of property access 4m wide plus 2x0.5m and one 6m x 20m passing bay about half way between the entry gate and the house site.

1. Create the Hazard Management Area over the area shown and prescribed in Annexure B, to the specifications in Annexure C. In particular, keep lawn mown to less than 25mm, and to the extent possible, keep it green by regular watering.
2. Upgrade the access road on the site to 4m width plus a 6 x 20m passing bay within 200m of either the entry point or the house site.
3. Complete construction to BAL-29 specifications under s3 and s7 of AS 3959-2018.
4. Install a non-combustible tank with 10kl capacity reserved for fire fighting plus an outlet and the signage and fittings specified in Annexure C, so that the outlet is within 3m of a tanker parked on the hardstanding. Fill the tank with water.

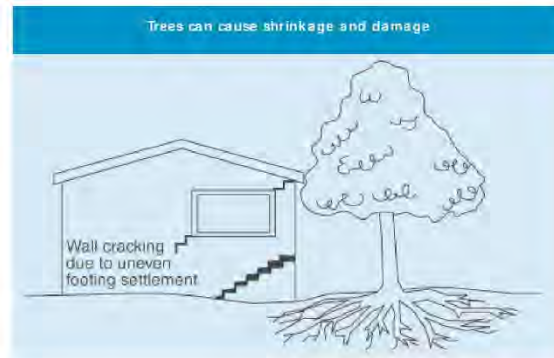
As the moisture absorption process completes its journey to the innermost areas of the building, the internal footings will rise. If the spread of moisture is roughly even, it may be that the symptoms will temporarily disappear, but it is more likely that swelling will be uneven, creating a difference rather than a disappearance in symptoms. In buildings with timber flooring supported by bearers and joists, the isolated piers will rise more easily than the strip footings or piers under walls, creating noticeable doming of flooring.

As the weather pattern changes and the soil begins to dry out, the external footings will be first affected, beginning with the locations where the sun's effect is strongest. This has the effect of lowering the external footings. The doming is accentuated and cracking reduces or disappears where it occurred because of dishing, but other cracks open up. The roof lines may become convex.

Doming and dishing are also affected by weather in other ways. In areas where warm, wet summers and cooler dry winters prevail, water migration tends to be toward the interior and doming will be accentuated, whereas where summers are dry and winters are cold and wet, migration tends to be toward the exterior and the underlying propensity is toward dishing.
